## Corrosion Analysis on Internal Plastic Coating Drill Pipe 5 Inch 19.50 PPF Grade G-105

### Abstract

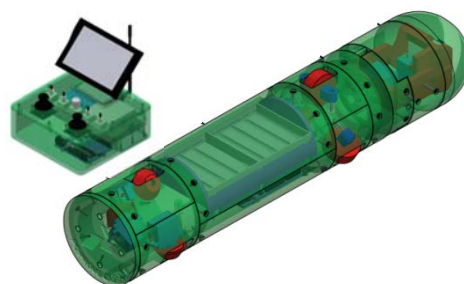
**Figure 1.** Prototype Automatic Drift With Internal Cam

Each drill pipe that will be used in the drilling program is subjected to an initial inspection to ensure the condition of the drill pipe is still suitable for use. After the drill pipe is used, every multiple of 1500 hours of running hours will be inspected in non-real time conditions or not when used in drilling. This research uses the Automatic Drift With Internal Cam prototype tool (Figure 1), which consists of two main parts, namely the transmitter and receiver. The transmitter functions to move the components in the receiver, including the servo which functions as a camera driver and direction. Where this tool can see the visual condition of the inside of the drill pipe.

1. A reduction in thickness of 2.2mm and 2.5mm from the initial thickness is obtained after the use of drill pipe with a span of 1500 hours to 3000 hours
2. From the samples conducted research, the highest corrosion rate is 0.25mm / month
3. From the results of the inspection with a span of 10 months, the internal condition of the plastic coating has decreased in quality. With the worst condition (IPC4) as many as 10 samples
4. The resulting Automatic Drift With Internal Cam prototype tool works well and can make it easier to monitor the internal plastic coating conditions

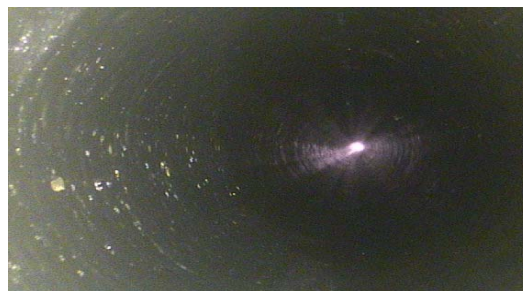
Internal Plastic Coating Condition 1

To inhibit corrosion of the internal parts of the drill pipe, the drill pipe has been coated with plastic coating, however, from the analysis and inspection reports, it was found that corrosion was quite significant in some drill pipes. The storage of the drill pipe in an open space and exposed to the sun allows the internal plastic coating to peel off so that it cannot completely protect the inside of the drill pipe. The pressure of the drilling mud when the user can erode the internal plastic coating itself, causing corrosion to the parts in the drill pipe. To find out the actual condition of the plastic coating, the Automatic Drift With Internal Cam prototype was used. In Figure 3 below is a comparison result of the internal plastic coating conditions using the DS-1 Volume 3 reference. Figure 1 is the condition of the internal plastic coating without any damage. Figure 2 is the condition of the internal plastic coating which is damaged by 30% of the total length of the pipe or from the surface area of the drill pipe. Figure 3 is the condition of the internal plastic coating which is damaged by 30% to 50% of the total length of the pipe or from the surface area of the drill pipe. Meanwhile, Figure 4 is the condition of the internal plastic coating which is damaged more than 50% of the total length of the pipe or from the surface area of the drill pipe.
